# Manhole Inspection Summary

Manhole # S47K\_\_014MH

Insp Date: **9/9/08 9:02 AM**

**Location** Address: **side 2321 leakin st**

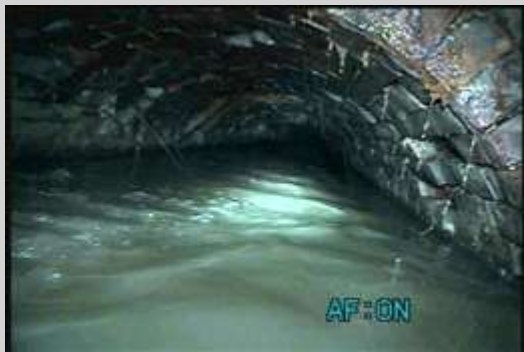
12 O'Clock Outflow

48 in. Circular Gravity Sewer  
Pipe Out @ 12 O'Clock

Pipe Material: **Concrete** ☐ Pipe Lined

Invert Depth: **20.83** (ft.) Flow Characteristics: **Fast**

Infiltration: **None** Pipe Seal Cond: **Unknown**

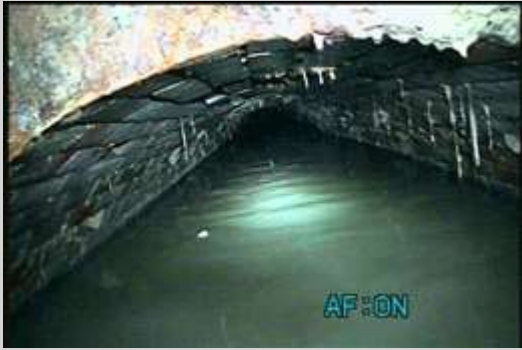
6 O'Clock Inflow

48 in. Circular Gravity Sewer

Pipe In @ 6 O'Clock

Pipe Material: **Concrete** ☐ Pipe Lined

Invert Depth: **20.66** (ft.) Flow Characteristics: **Fast**

Infiltration: **None** Pipe Seal Cond: **Unknown**

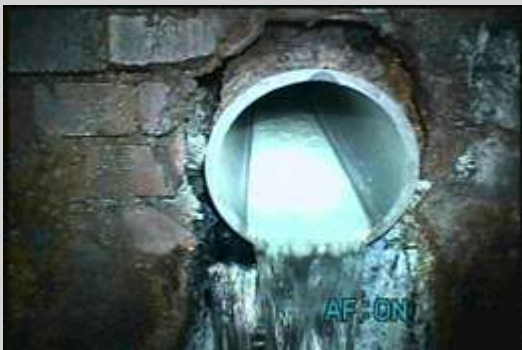
9 O'Clock Inflow

10 in. Circular Gravity Sewer

Pipe In @ 9 O'Clock

Pipe Material: **Clay** ☐ Pipe Lined

Infiltration: **None** Pipe Seal Cond: **Unknown**
